SNAP-8 TOPICAL MATERIALS REPORT FOR 1962

VOL. III - SNAP-8 MERCURY CORROSION AND MATERIALS RESEARCH

SNAP-8 MERCURY CORROSION AND MATERIALS RESEARCH

Topical Report

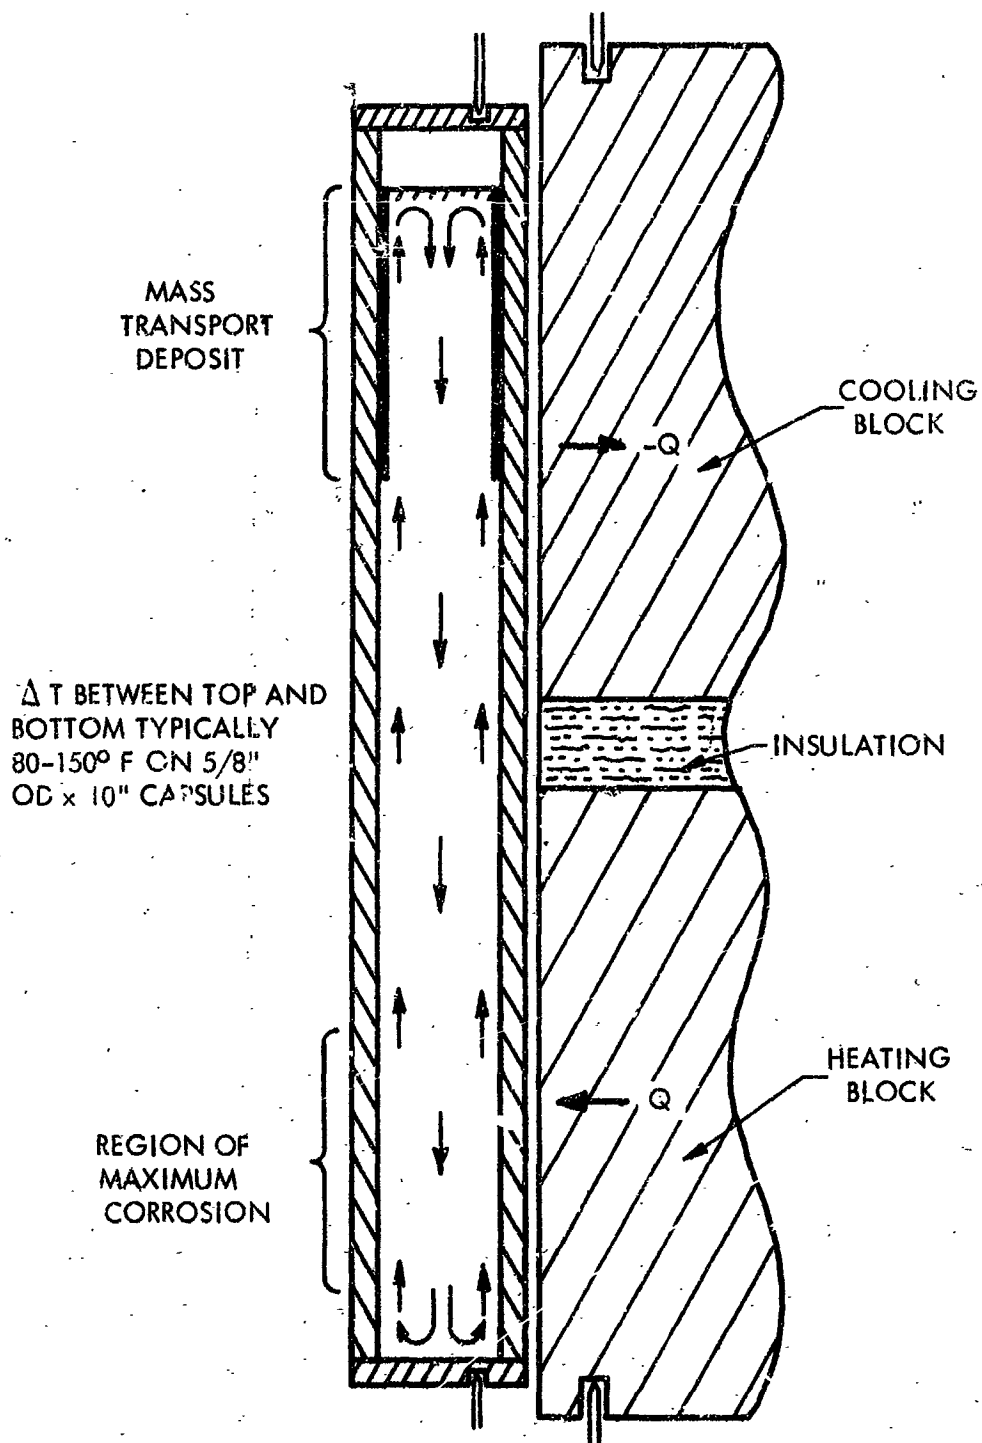
The principle of the capsule design and test method is illustrated in Figure 1. A furnace (described in Section B) contained two 6 in. dia. x 6 in. long blocks, each with 19 holes and separated by insulation. The bottom block was enclosed in clam shell heaters and the top block was unheated. Capsules were mounted in the holes so that the bottom half was heated by the bottom block. The ΔT between top and bottom of capsule varied between 80° and 150°F depending on the nominal temperature, the type of material, and the length of time since start up. This situation created a natural convection flow pattern as shown in Figure 1. The liquid being heated at the bottom of the capsule ascended next to the wall and descended at the axis. The wall along the bottom half of the capsule dissolved into the rising film of liquid. When this film reached the upper half and cooled, the liquid became supersaturated and the solute precipitated to form a deposit on the wall or a powder in the liquid. By keeping all capsules under a similar ΔT , it was expected that relative differences between alloys could be measured.

FIGURE 1. OPERATION PRINCIPLE OF NATURAL CONVECTION CAPSULE

This flow system had been studied by Hartnett, Welch, and Larson⁶ at a length-to-diameter ratio of 21. Heat transfer had been correlated against a modified Grashof-Prantl number. The Types A and B capsules were selected with this same ratio because it was hoped that

further analysis of the system would result in an analogous correlation of mass transfer. A somewhat simpler system had been correlated in both natural and forced convection.⁷ The analysis was eliminated during later changes in scope of the program so no attempt at correlation was made.

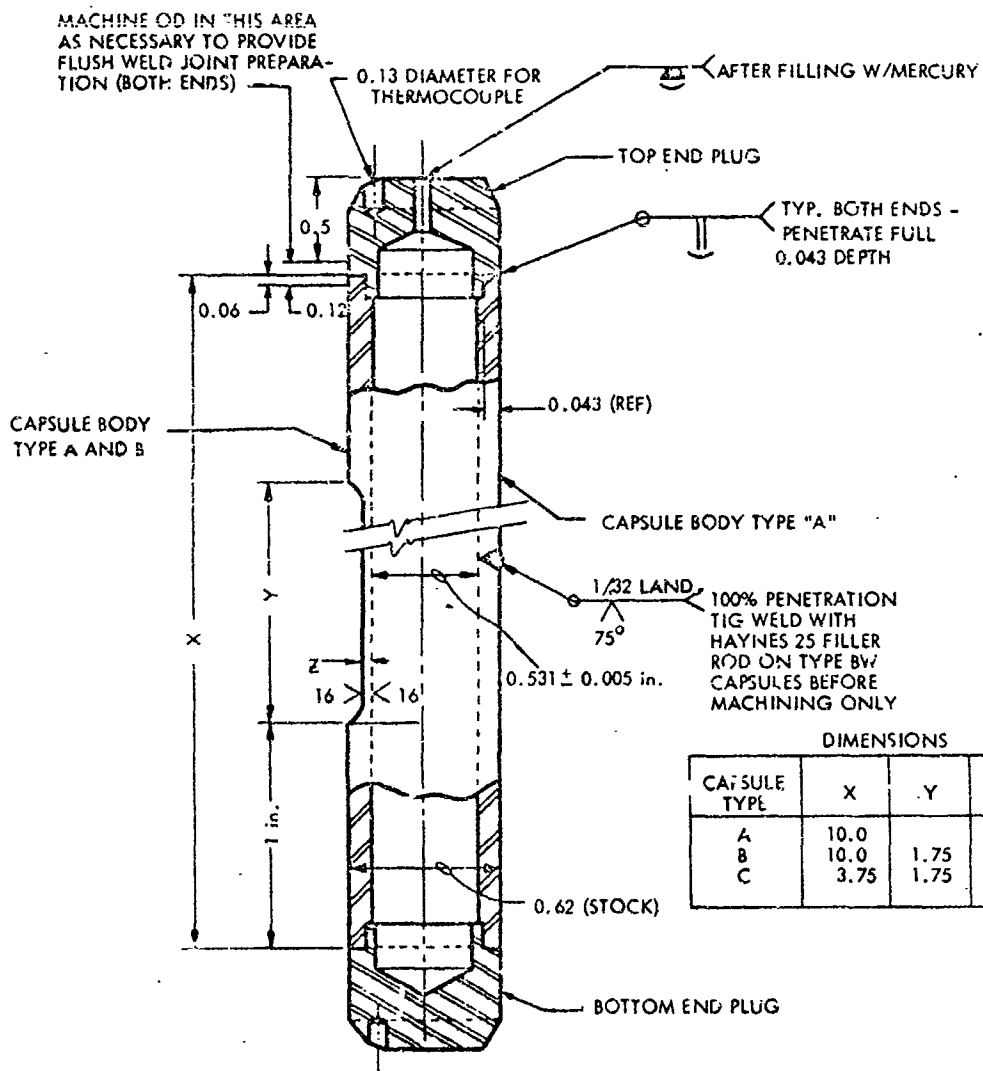
FIGURE 2. CAPSULE DESIGN

The capsules were filled with triple distilled mercury to a level calculated to maintain the liquid surface just above the top weld. Discoloration and the corrosion pattern after the runs indicated that this level was obtained.

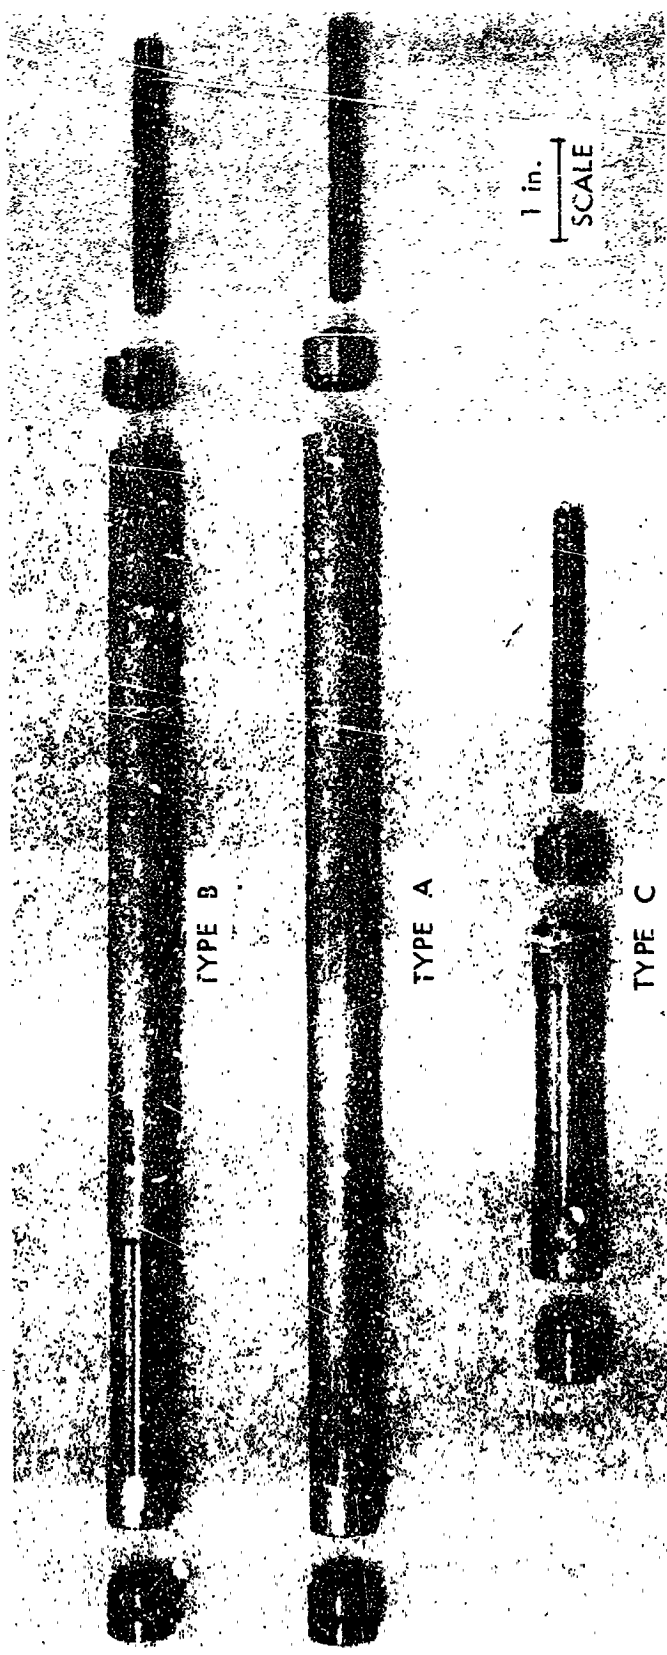
FIGURE 3. FINAL MACHINED CAPSULE PARTS

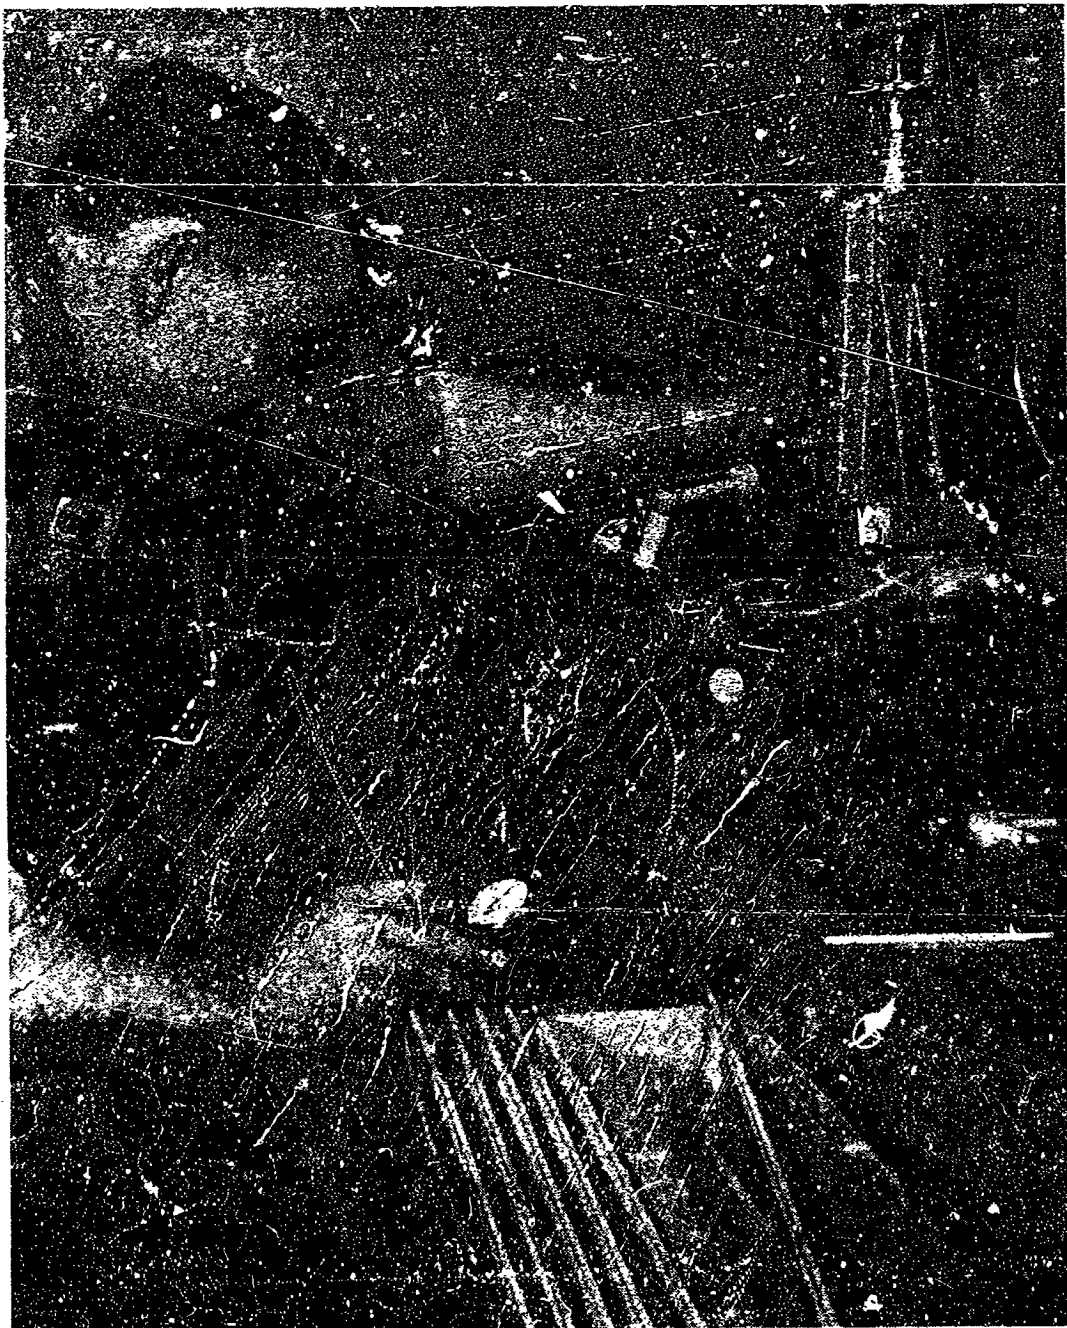
FIGURE 4. SEMIAUTOMATIC WELDING OF CAPSULE

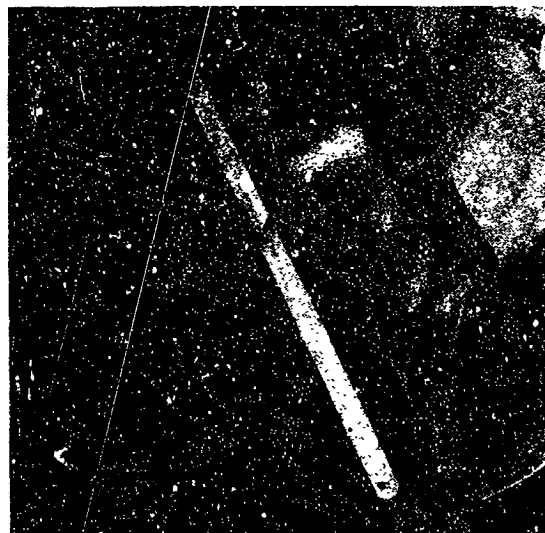
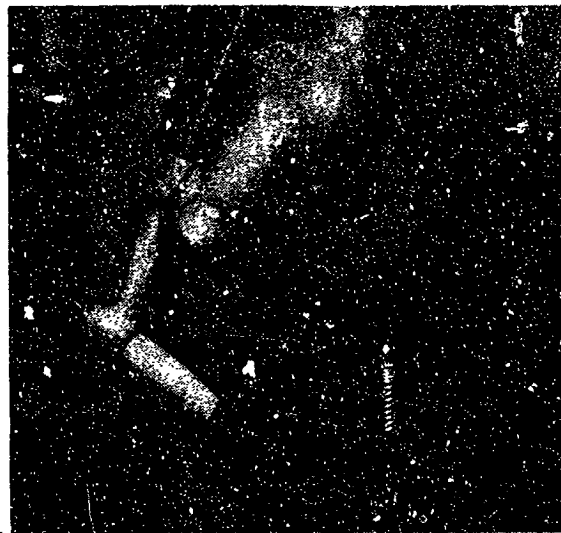
a. EVACUATING CAPSULES

b. PINCHING FILL TUBE

c. CUTTING OFF FILL TUBE

d. WELDING FILL TUBE

FIGURE 5. EVACUATING AND SEALING VACUUM TYPE CAPSULES

- 10) Place capsules in vacuum glove box and evacuate overnight.

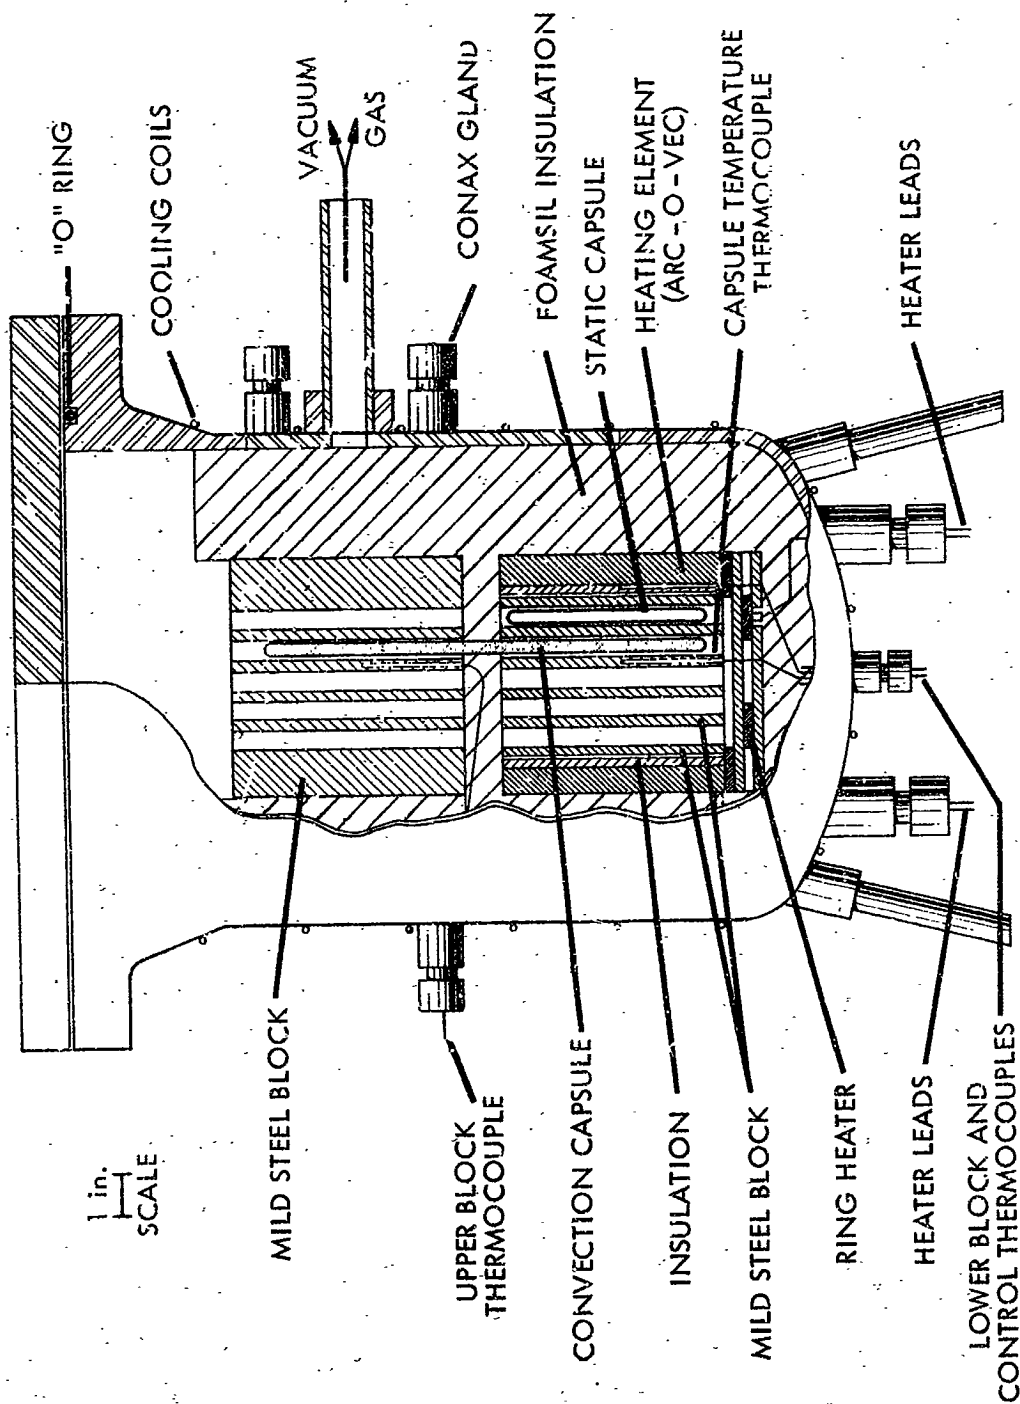
FIGURE 6. CORROSION CAPSULE FURNACE

The furnaces could be operated up to 295 psia pressure or under vacuum. All but short periods were conducted under vacuum less than 1×10^{-3} torr using a fore pump and dry ice/acetone cold trap.

The temperatures were measured with Aero Research 1/16 in. OD, MgO-insulated stainless steel sheathed Chromel-Alumel thermocouples. Conax glands were used for heater and thermocouple feed throughs. The higher temperatures also tended to result in a smaller ΔT . Thermocouples were mounted in various locations in the blocks and in the holes at both ends of 2 capsules at opposite sides of the block. Temperatures were uniform radially and the gradient between top and bottom of the capsules varied between 85 and 150°F. The tests were interrupted at 500 or 1000-hour intervals to remove capsules, take diametral measurements, or start new capsules. The wider gradient occurred at the start of each interval and narrowed after

The furnaces originally were built with a copper heating block and an aluminum cooling block to take advantage of their high thermal conductivities. A capsule leaked Hg early in the 1100°F run, forming a low melting eutectic with the Cu and Al and destroying some of the capsules. The blocks were then replaced with the mild steel blocks.

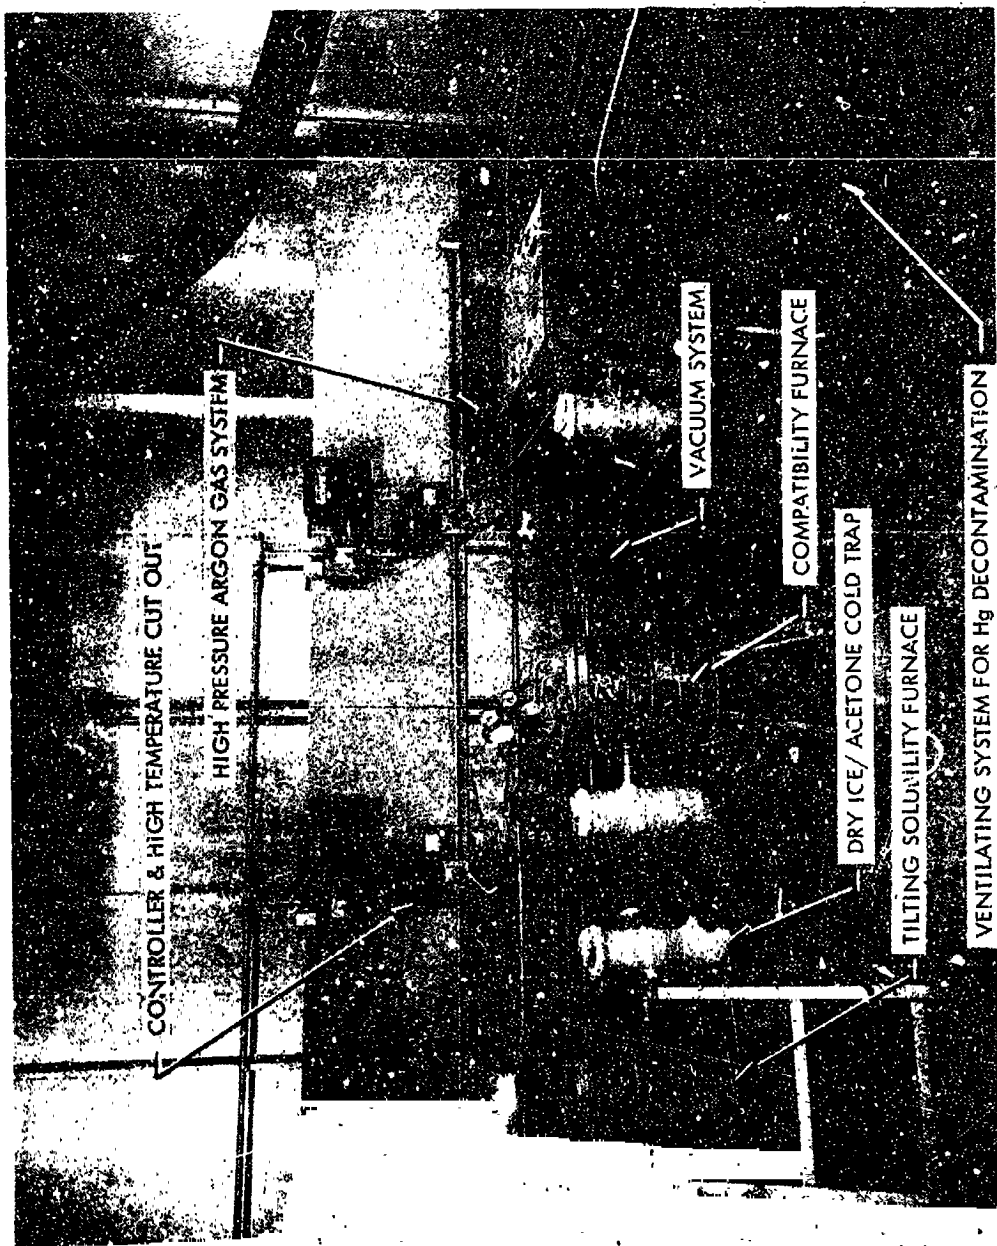
FIGURE 7. CAPSULE FURNACE FACILITY

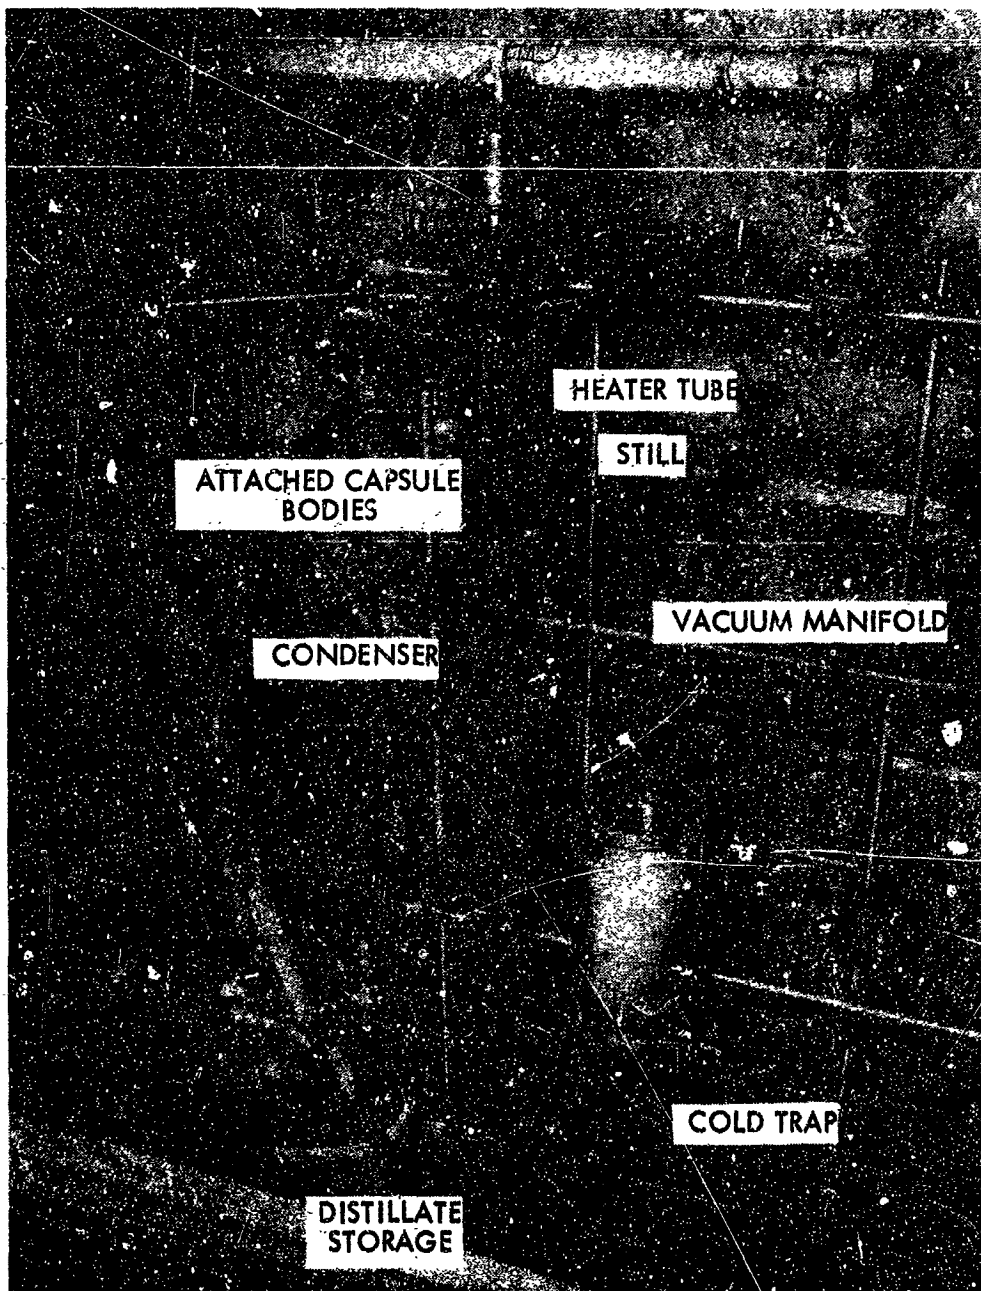
FIGURE 8. CAPSULE DECONTAMINATION STILL

- 1) Open by sawing at the top until a small hole is made.
- 2) Pour Hg into large test tube and save.
- 3) Cut off ends of capsule.
- 4) Evaporate Hg from capsule bodies by molecular distillation ($\sim 200^\circ\text{F}$) in the apparatus shown in Figure 8.
- 5) Evaporate Hg from test tube in the same apparatus (certain capsules only).
- 6) Recover the loose powder from Steps 4) and 5) and weigh.
- 7) Measure capsule diameters.
- 8) Cut samples for micrographic examination.
- 9) Cut sample for tensile test (certain capsules only).

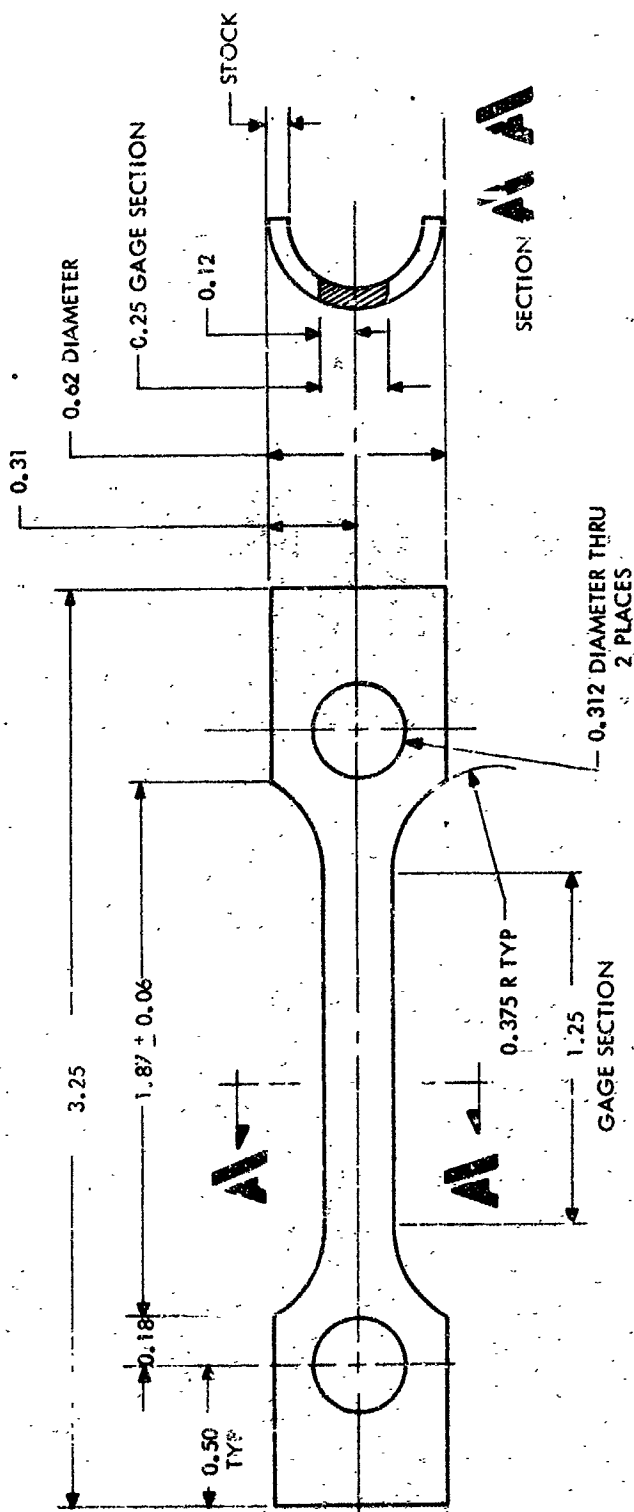
DIMENSIONS IN INCHES

FIGURE 9. TENSILE SPECIMEN MACHINED FROM CAPSULE WALL

It was decided to measure the effects of exposure on the Haynes 25 and Type 405 stainless steel by machining tensile specimens from the walls of the tested capsules rather than use inserts. In this way the effect of stress history would be included. This required a special specimen, as shown in Figure 9. Special grips were also fabricated. Those used for room temperature tests are shown in Figure 10 and those for elevated tests in Figure 11. Tests were performed on as-received tubing to check out the grips and to obtain reference data.

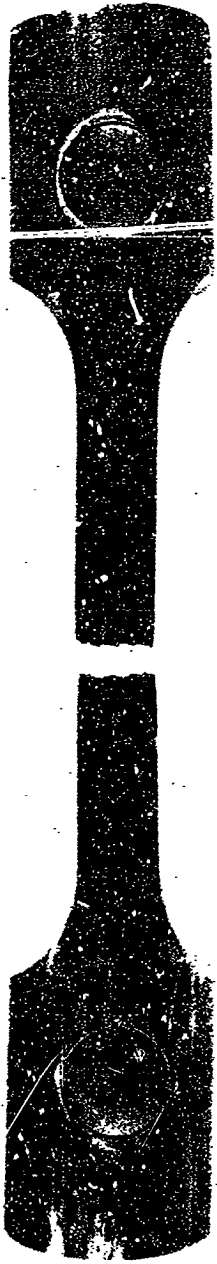
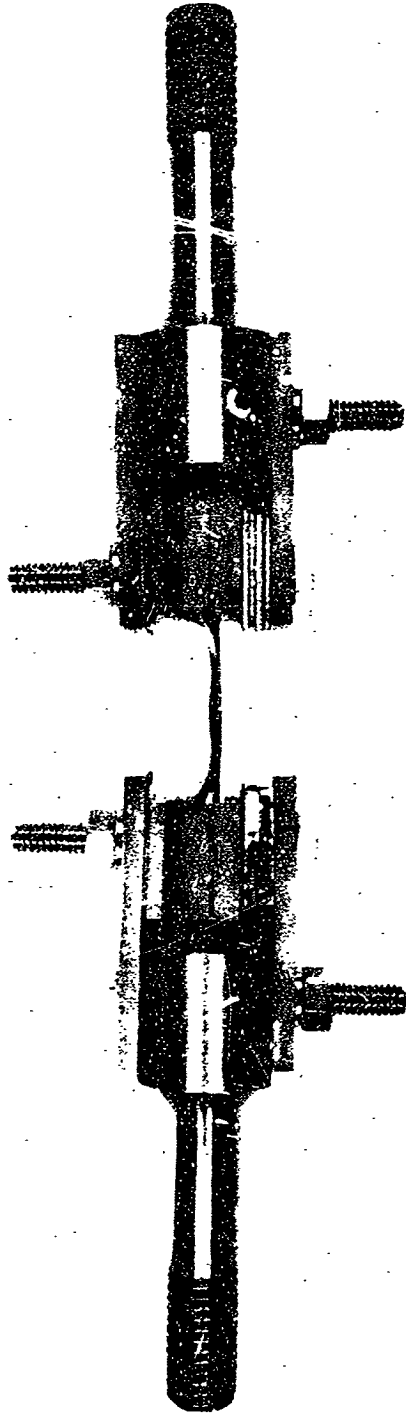
TYPICAL BROKEN TENSILE SPECIMEN

TENSILE GRIP ASSEMBLY

FIGURE 10. TENSILE SPECIMENS AND GRIPS USED FOR ROOM TEMPERATURE TESTING

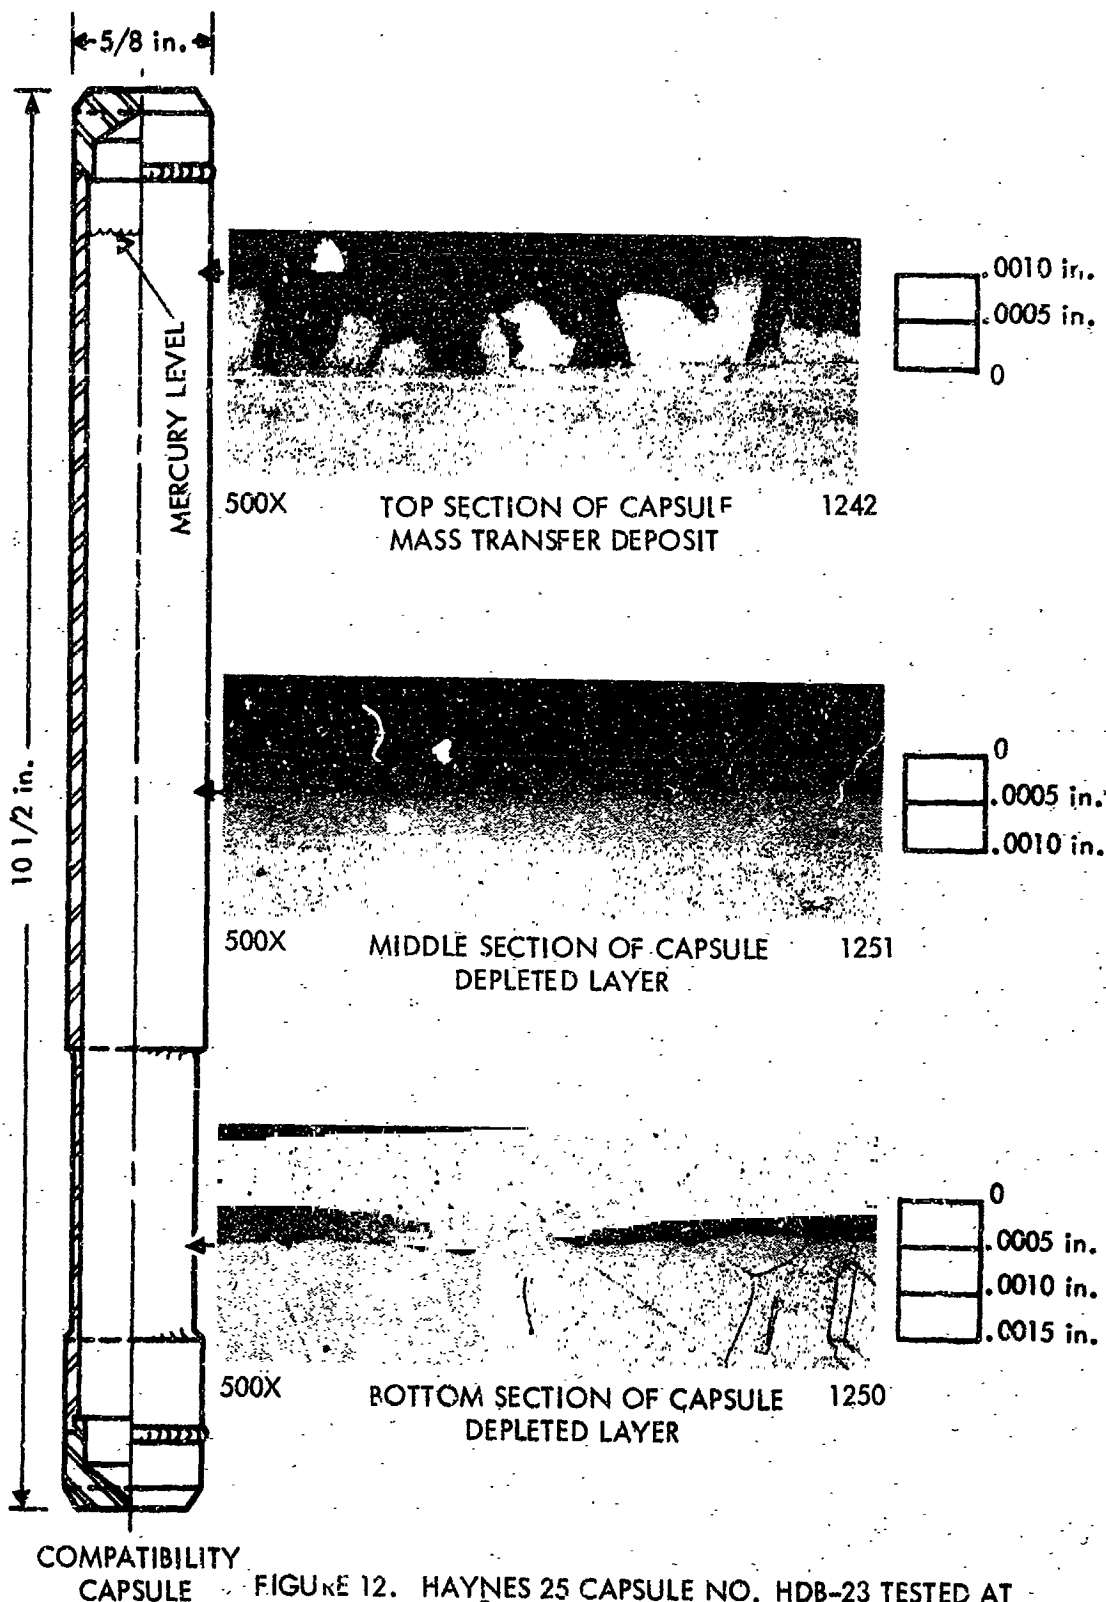
Corrosion effects were found along the full length of the capsule (Figure 12). An evenly depleted layer was found along the bottom half of the capsule, averaging approximately 0.0006 in. deep. A mass transfer deposit was found in a layer of variable density along the top half, extending to the liquid surface. The two layers merged abruptly at the point where the bottom and top positioning blocks met in the furnace. This point corresponded to a sharp change in the temperature gradient along the capsule. The mass transfer deposit was most dense about two inches from the top weld. The largest crystals are shown to be about 0.001 in. at their longest dimension. The composition of the crystals has not been determined, but since the loose powder found in the Hg was predominantly Co (as discussed later), it is believed they are primarily solid solutions of Ni and Cr.

FIGURE 12. HAYNES 25 CAPSULE NO. HDB-23 TESTED AT 1025°F FOR 2000 HOURS

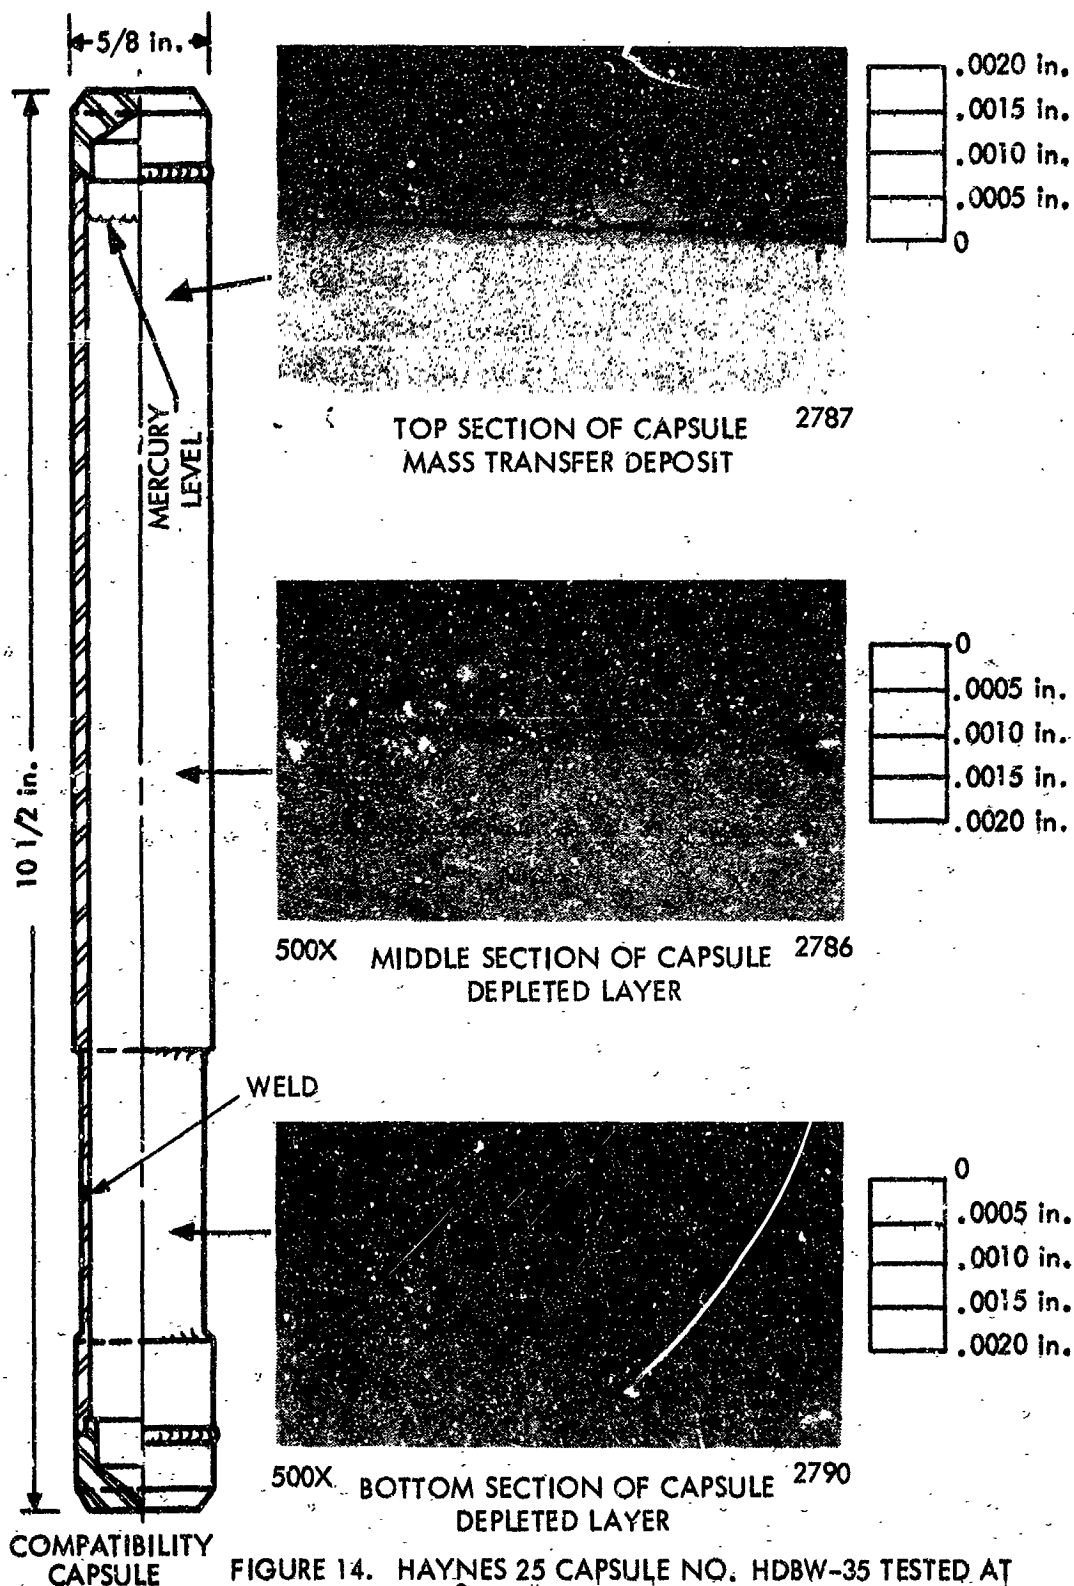
Examination of the microstructure along the entire length of the capsule showed a typical depleted surface layer of the tube wall at the bottom of the capsule. A mass transfer deposit was found at the top of the capsule. Typical microstructures are shown in Figure 14. The depleted layer was approximately 0.002 in. deep. No spalling of the depleted layer was observed.

FIGURE 14. HAYNES 25 CAPSULE NO. HDBW-35 TESTED AT 1025°F FOR 10,000 HOURS

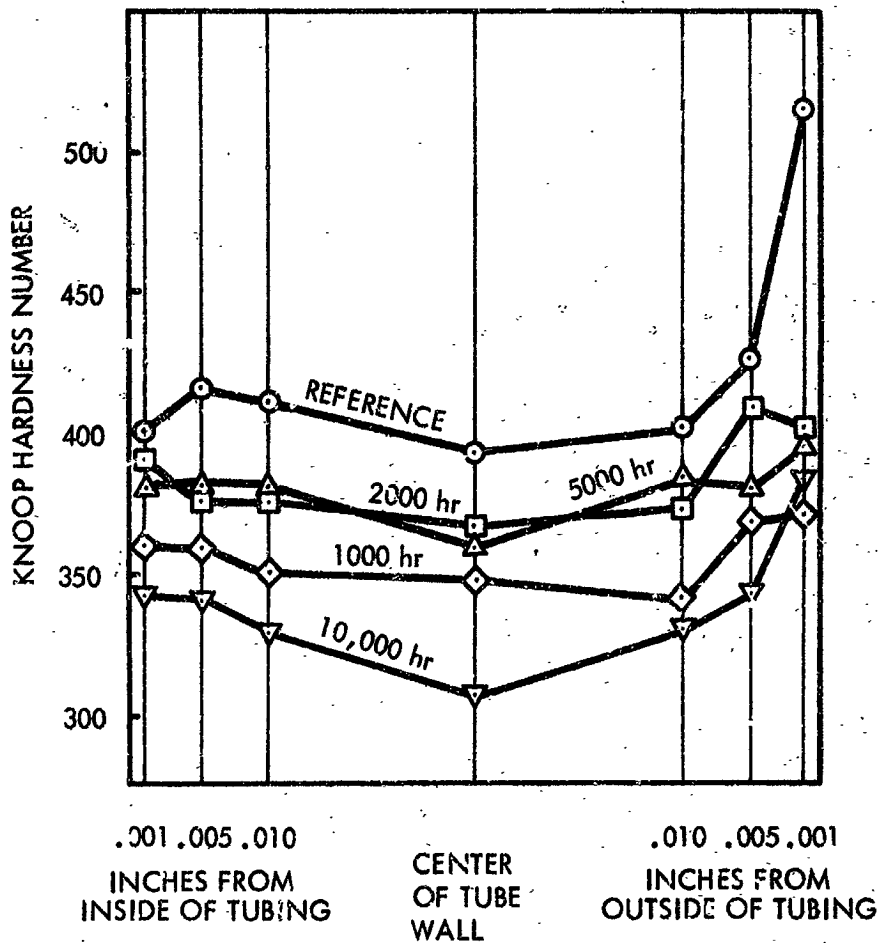
FIGURE 15. MICROHARDNESS SURVEY, HAYNES 25 LOT D EXPOSED TO MERCURY AT 1025°F

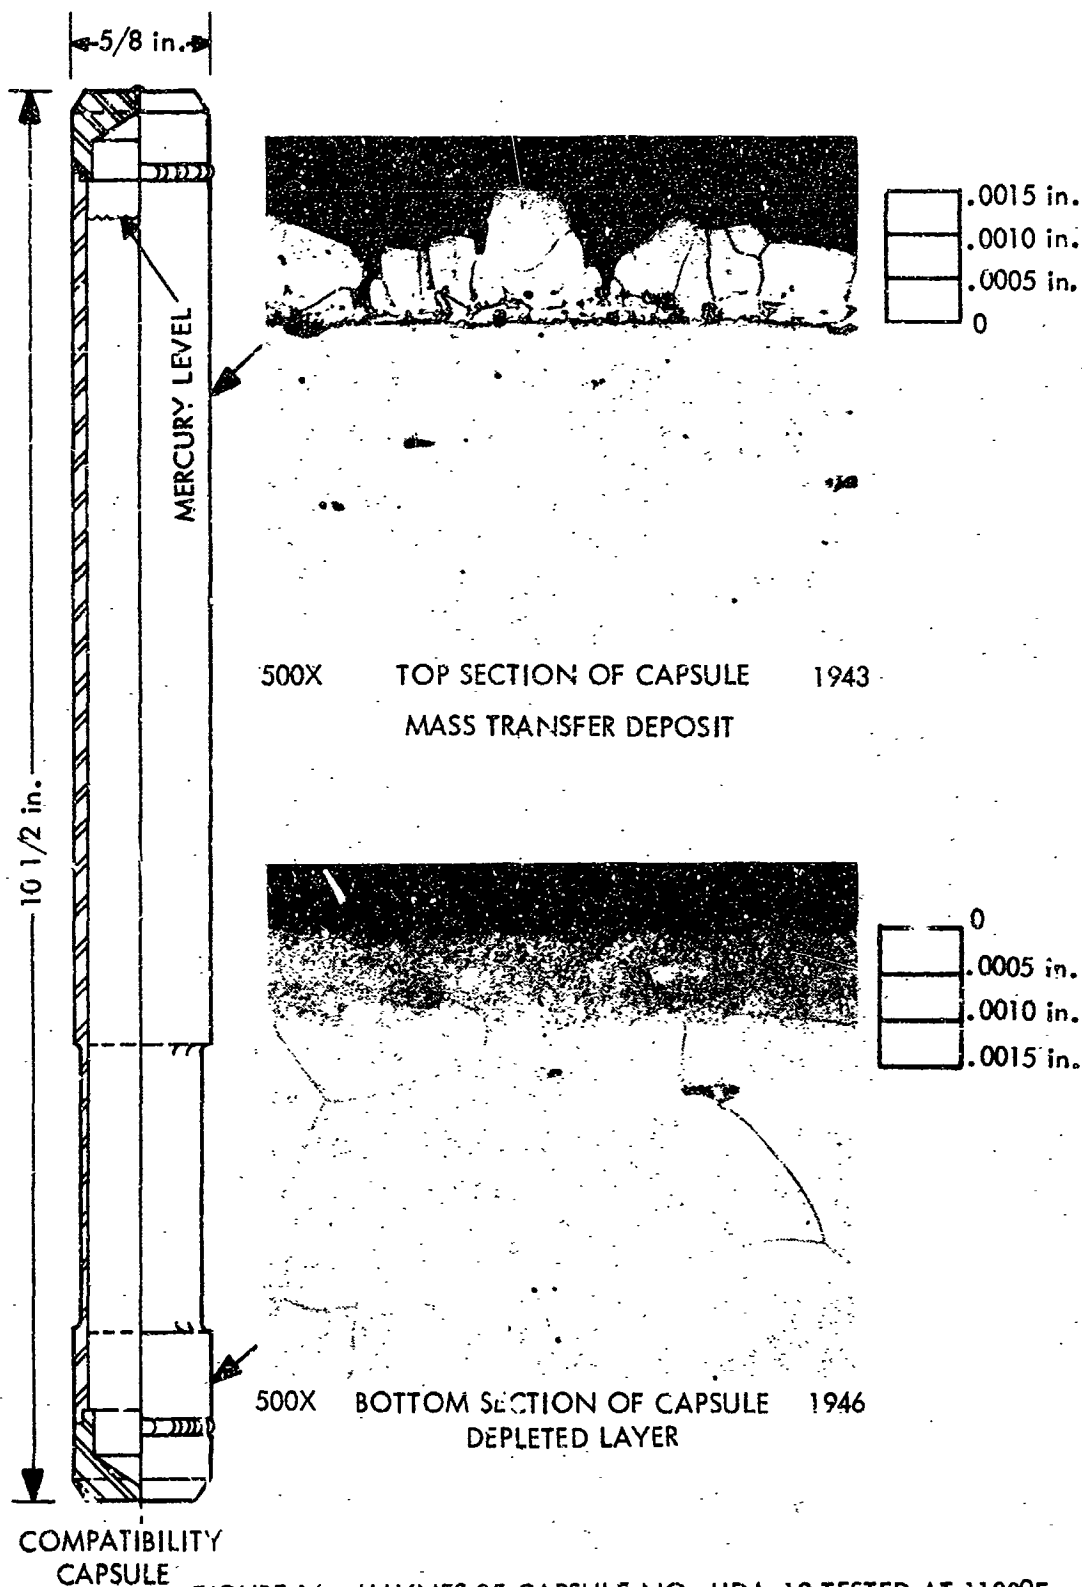
This capsule showed the same corrosion pattern found in the 5000 hour, 1025°F capsule. The depleted layer was approximately 0.0013 in. deep and extended to the middle of the capsule. No evidence of spalling of the depleted layer was found. The mass transfer deposit formed near the top of the capsule built up to 0.0015 in. maximum. Typical sections of the top and bottom portions of the capsule are shown in Figure 16.

FIGURE 16. HAYNES 25 CAPSULE NO. HDA-19 TESTED AT 1100°F FOR 5000 HOURS

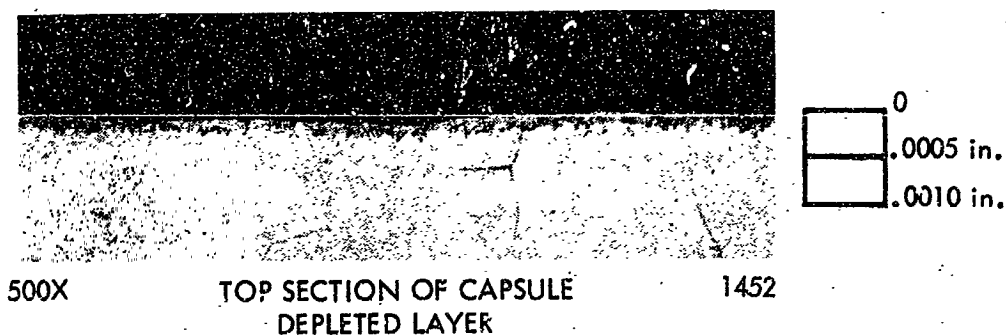
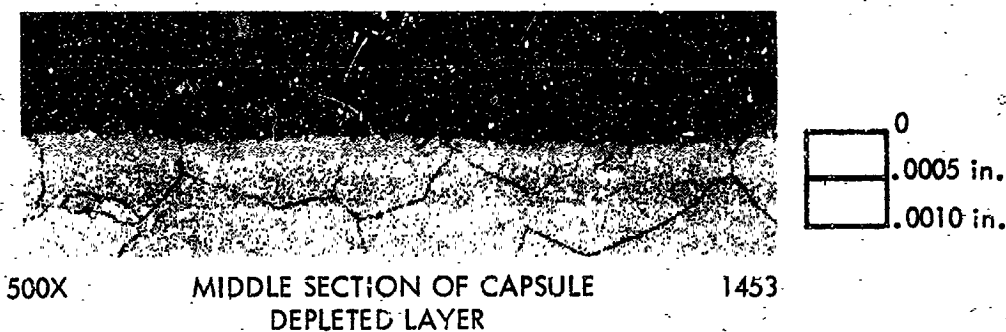
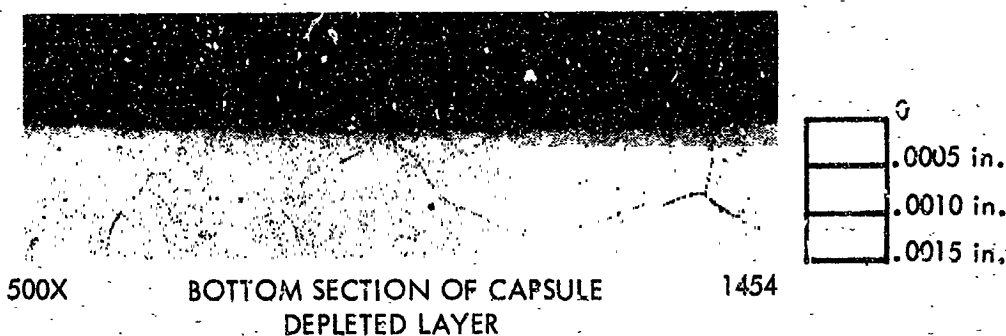
A depleted layer varying from 0.00013 to 0.0003 in. thick was found along the length of the 5000 hour isothermal capsule. No correlation between depth and position along the capsule was noted. The elements leached from the depleted layer apparently precipitated in the Hg and no mass transfer deposit was formed. Photomicrographs of the top, middle, and bottom sections of the capsule are shown in Figure 18.

FIGURE 18. HAYNES 25 CAPSULE NO. HDC-14 TESTED AT 1100°F FOR 5000 HOURS

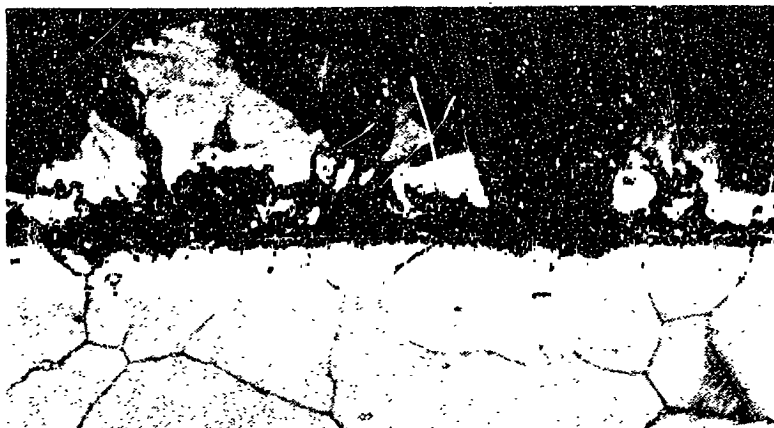
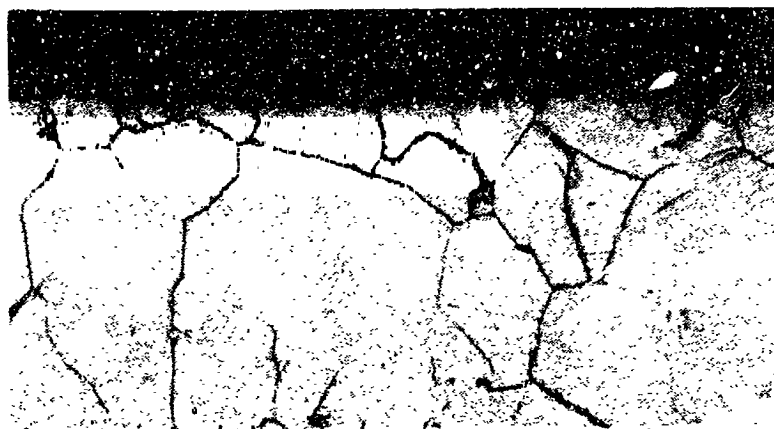
A very thin depleted layer was found along the entire length of the capsule and a mass transfer deposit was evident near the top. Typical sections of the top and bottom of the capsule are shown in Figure 19. This capsule was a vacuum type capsule and it is believed that the mass transfer deposit resulted from refluxing in the space above the liquid.

TOP SECTION OF CAPSULE
MASS TRANSFER DEPOSIT
AND DEPLETED LAYER

BOTTOM SECTION OF
CAPSULE
THIN DEPLETED LAYER

FIGURE 19. HAYNES 25 CAPSULE NO. HDC-11 TESTED AT 1100°F
FOR 10,000 HOURS

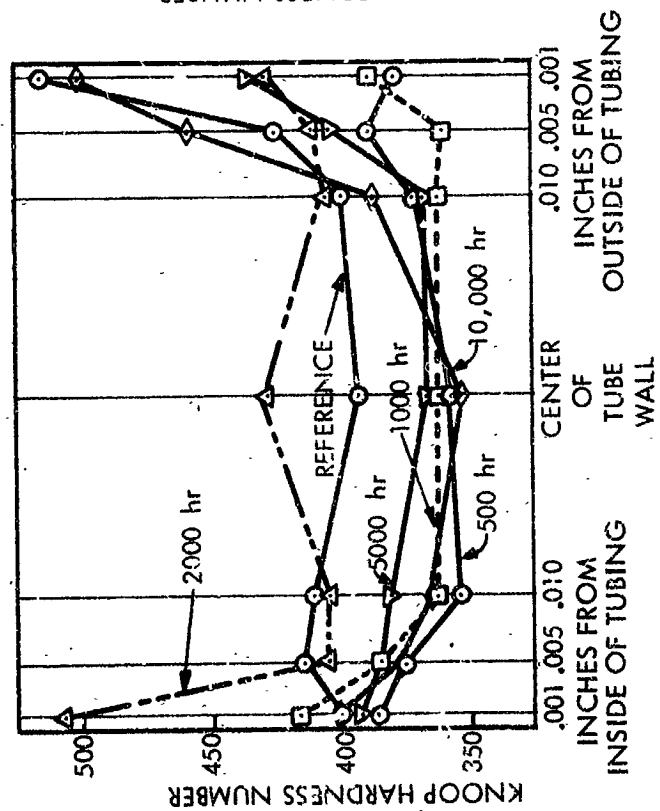
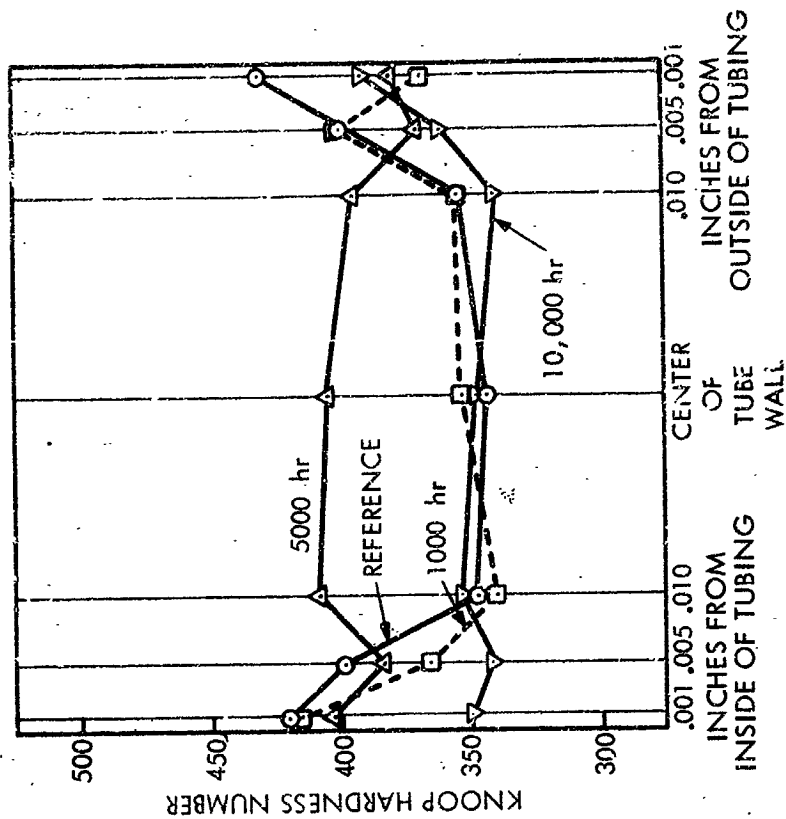
FIGURE 20. MICROHARDNESS SURVEY, HAYNES 25 EXPOSED TO MERCURY AT 1100°F
